Merthyr Mawr Dune Rejuvenation Works Topographic Survey Report

Report No: 99

Date: March 2015

Merthyr Mawr Dune Rejuvenation Works Topographic Survey March 2015

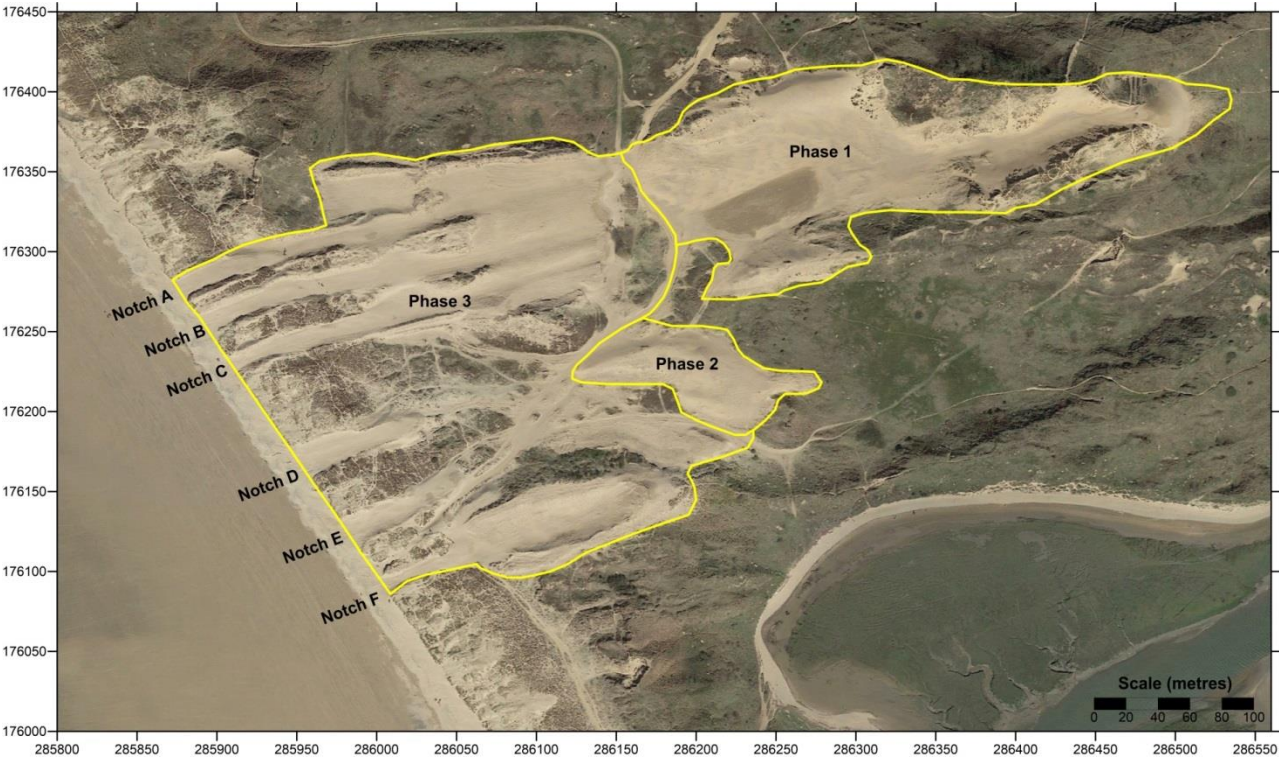
Figure 1. The three phases of dune rejuvenation at Merthyr Mawr, with works being undertaken in December 2012 (Phase 1), November 2013 (Phase 2) and November 2014 (Phase 3).

A third phase of rejuvenation works (referred here as 'Phase 3') was undertaken in November 2014, to the west of the Phase 1 and Phase 2 sites. Six notches were cut in the frontal dunes, and the dunes behind stripped of vegetation, to provide a pathway for sand to migrate inland from the beach and to maximise the possibility of retaining bare mobile sand into the future (Ludlow, 2014).

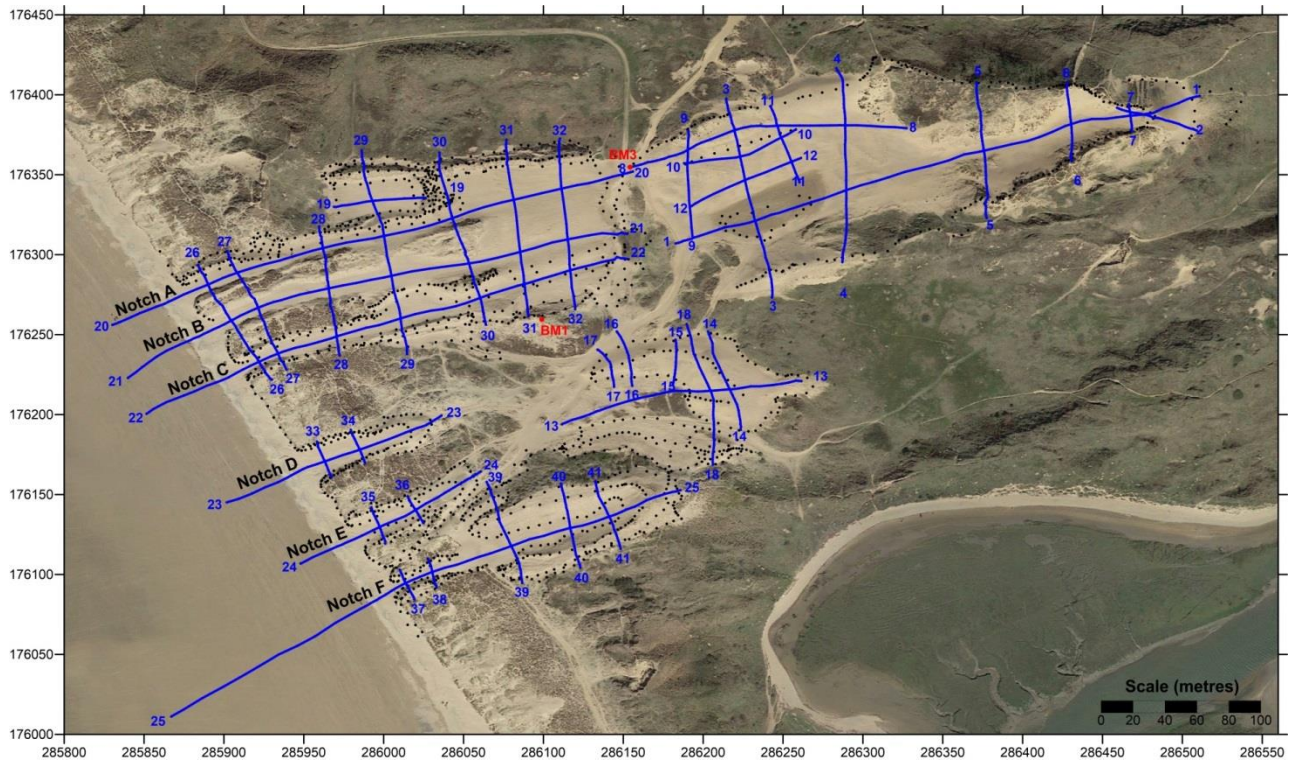
Figure 2. Locations of March 2015 data points (black dots), benchmarks (red dots) and cross-profiles (blue lines), overlaid on air photographs flown 18 April 2015 (source: Google Earth).

The locations of the survey points are shown in Figures 3 and 4.

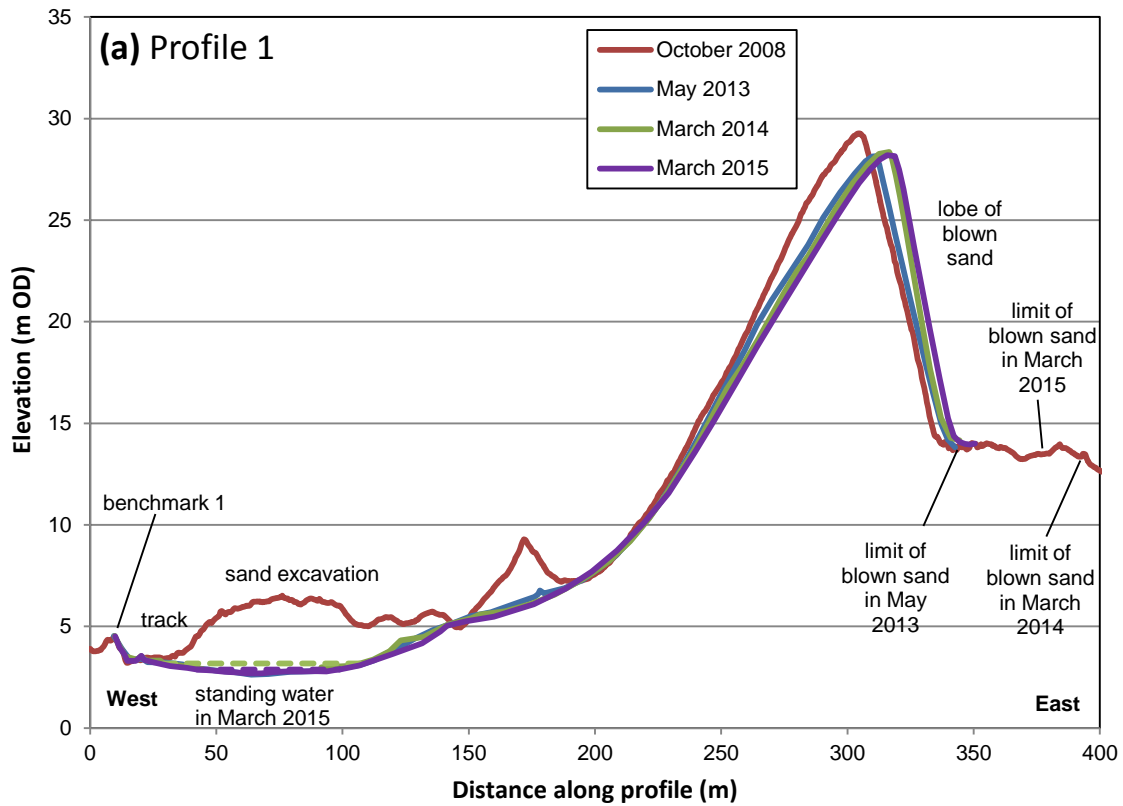
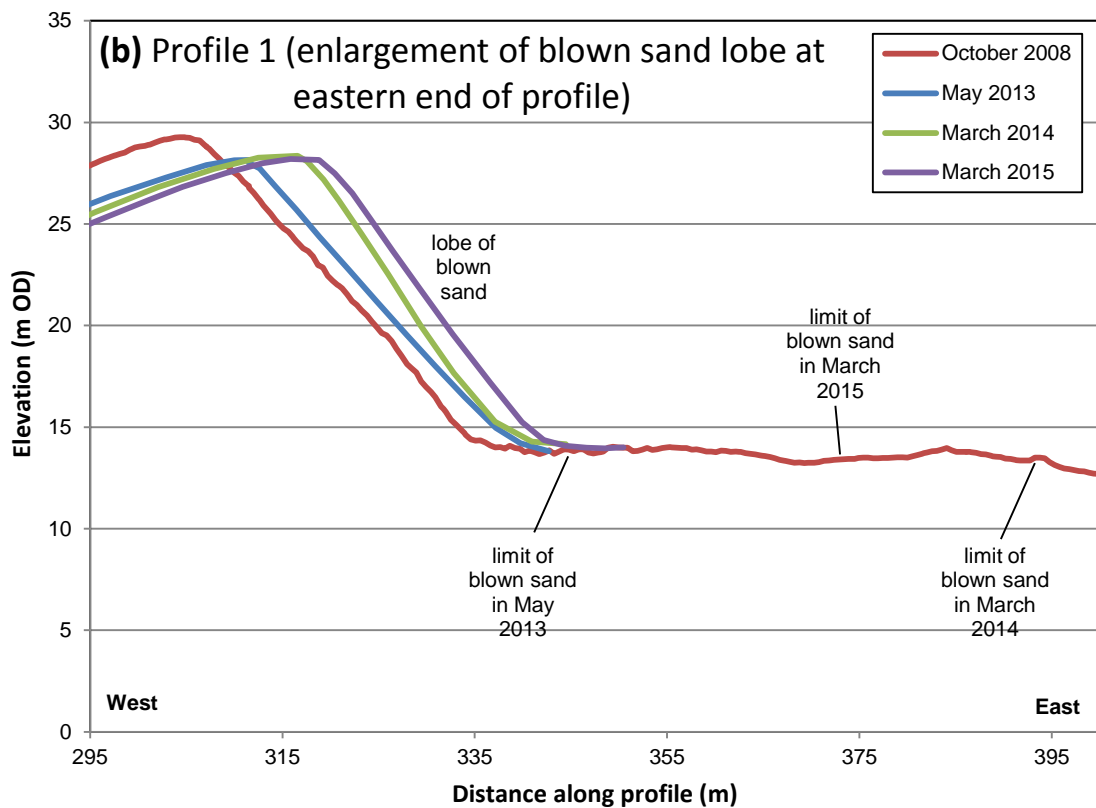
Figure 6. Comparison of surface levels at profile 1 on the Phase 1 site indicated by LiDAR survey on 16-29th October 2008 (pre-trials) and ground surveys on 14 May 2013, 11 March 2014 and 11-12 March 2015.

Forty-one profiles are compared in Figures 6-8. Profiles 1 and 2 along the central axis and slip face of the large parabolic dune in the Phase 1 area show significant sand movement since March 2014. Some lowering and eastward movement of the upper stoss (windward -facing) slope of the dune is evident, and the 20 m OD contour on the slip face (leeward side of the crest) showed an annual landward movement of 2.33 to 2.66 m between 2013 and 2015, equal to or larger than the apparent movement between 2008 and 2013 (Table 6). Most of the movement can be attributed to the greater extent of bare sand and greater wind funnelling after the works undertaken in December 2013, to the relatively windy conditions experienced in the autumn and winter of 2013-14, and to the greater wind exposure and sand supply from the Phase 3 area since November 2014.

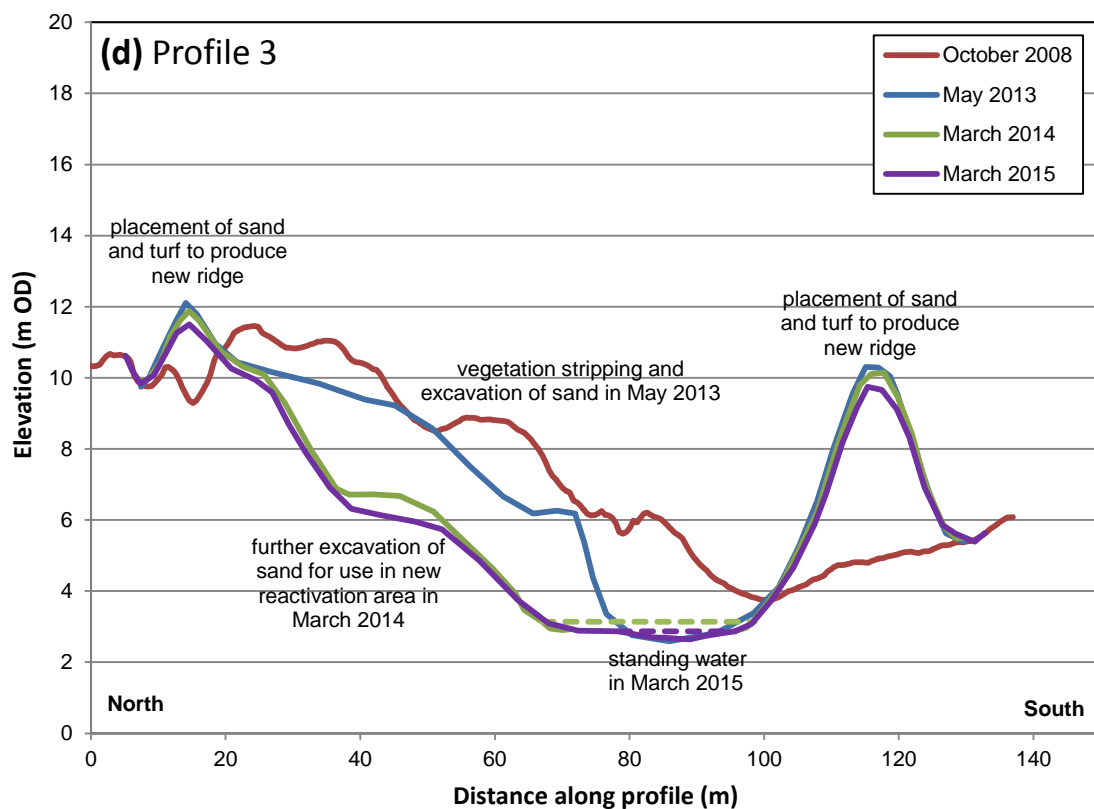
Figure 6 (continued). Comparison of surface levels at profiles 2 and 3 on the Phase 1 site indicated by LiDAR survey on 16-29th October 2008 (pre-trials) and ground surveys on 14 May 2013, 11 March 2014 and 11-12 March 2015.

Profiles 3 and 4 illustrate the reduction in the level of the crest of the western and eastern arms of the Phase 1 site, of 0.5 to 1.0 metre, with subsequent redistribution of surface sand by the wind. In the central Phase 1 area, where vegetation is beginning to establish, very little change is evident (Profile 5). Sand is accumulating in the bowl near the head of the dune (Profile 6), but continuing to migrate over the top of the dune down the slip face, with the top lip gradually reducing in elevation (Figure 7) by approximately 1 m since the rejuvenation works. Very little change is evident in the northwest corner of the Phase 1 area, since sediment was excavated for the Phase 2 area. Very minor sand deflation and accumulation has occurred, although no significant vegetation is becoming established (Figures 8-12).

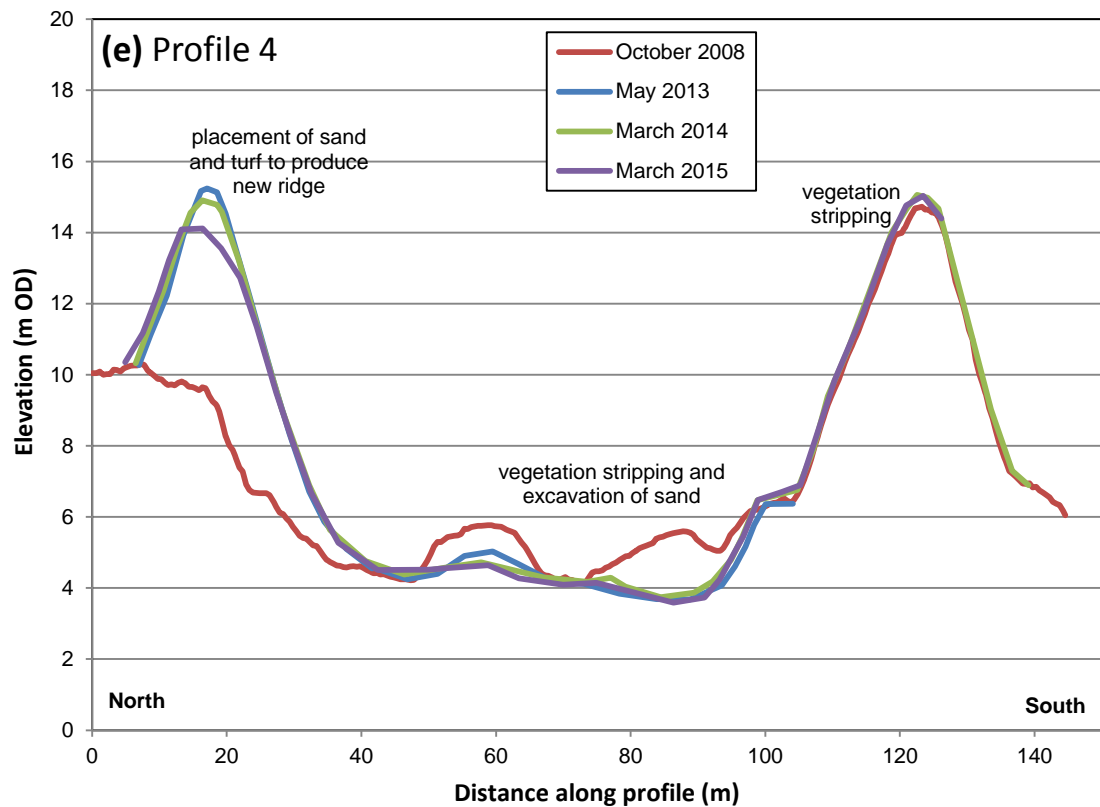
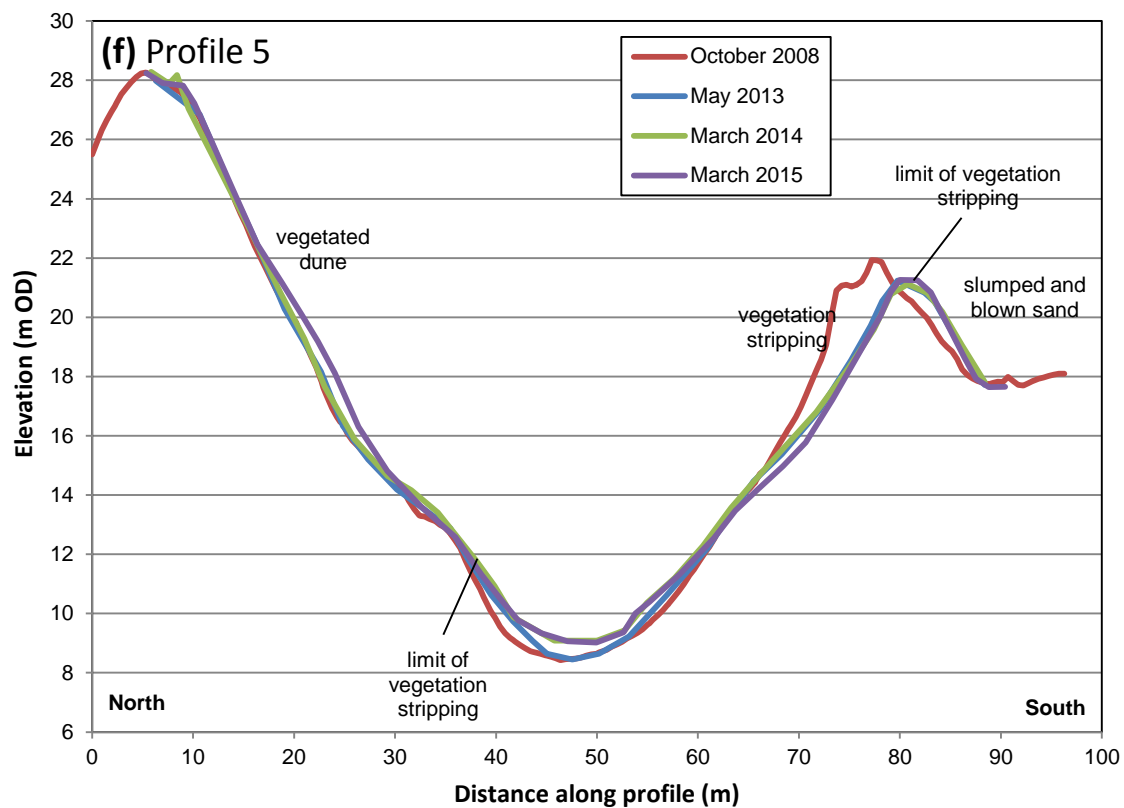
Figure 6 (continued). Comparison of surface levels at profiles 4 and 5 on the Phase 1 site indicated by LiDAR survey on 16-29th October 2008 (pre-trials) and ground surveys on 14 May 2013, 11 March 2014 and 11-12 March 2015.

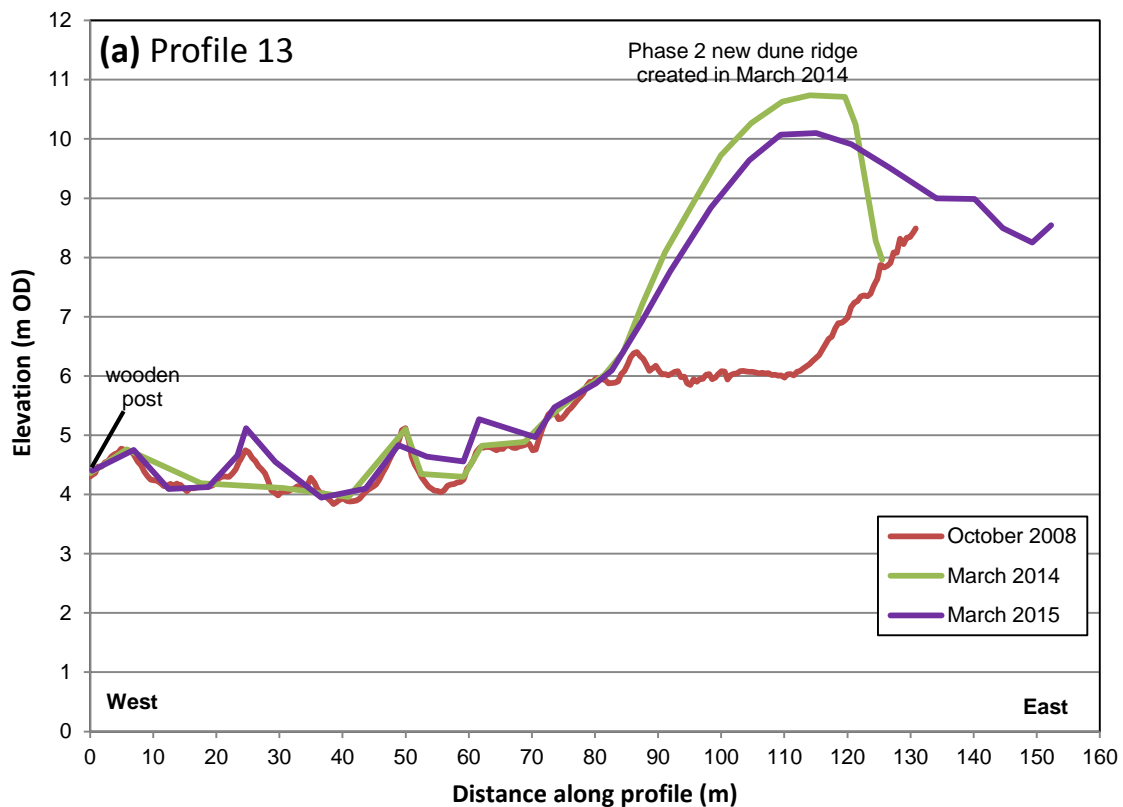
Figure 7. Comparison of surface levels at profiles 13 and 14 on the Phase 2 site indicated by LiDAR survey on 16-29th October 2008 (pre-trials) and ground surveys on 11 March 2014 and 11-12 March 2015.

Profiles 13 to 18 document changes to the Phase 2 area since works were undertaken. The surface level of much of the dune has dropped by 70-80 cm in the year since March 2014, with sand evidently migrating eastwards with the prevailing wind. Blown sand now extends 25 m further east than in March 2014, with a gentler slip face than was created as part of the works (see the eastern end of Profile 13).

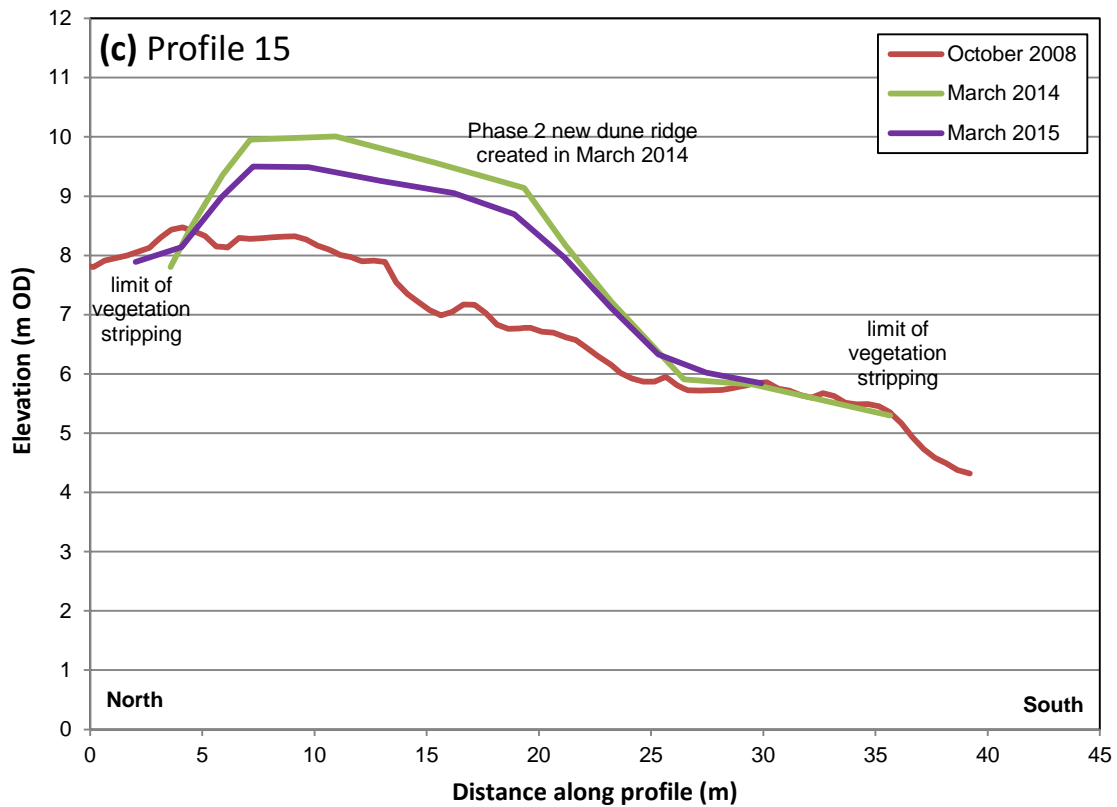
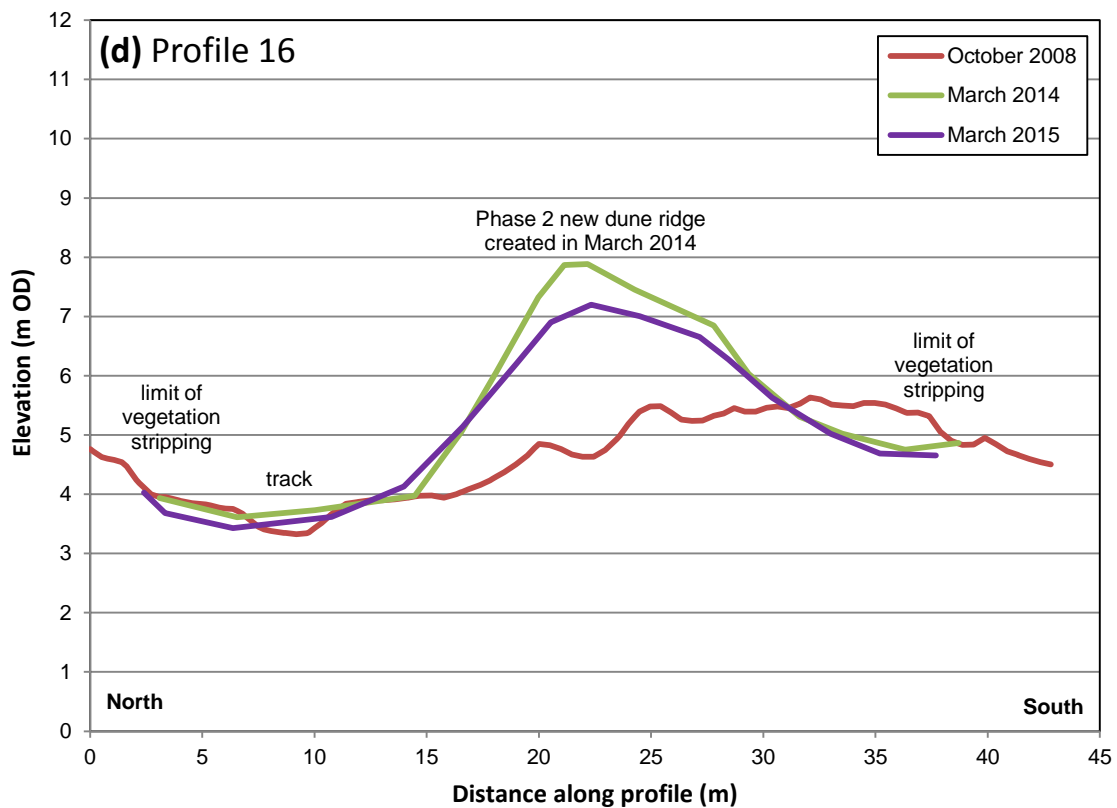
Figure 7 (continued). Comparison of surface levels at profiles 15 and 16 on the Phase 2 site indicated by LiDAR survey on 16-29th October 2008 (pre-trials) and ground surveys on 11 March 2014 and 11-12 March 2015.

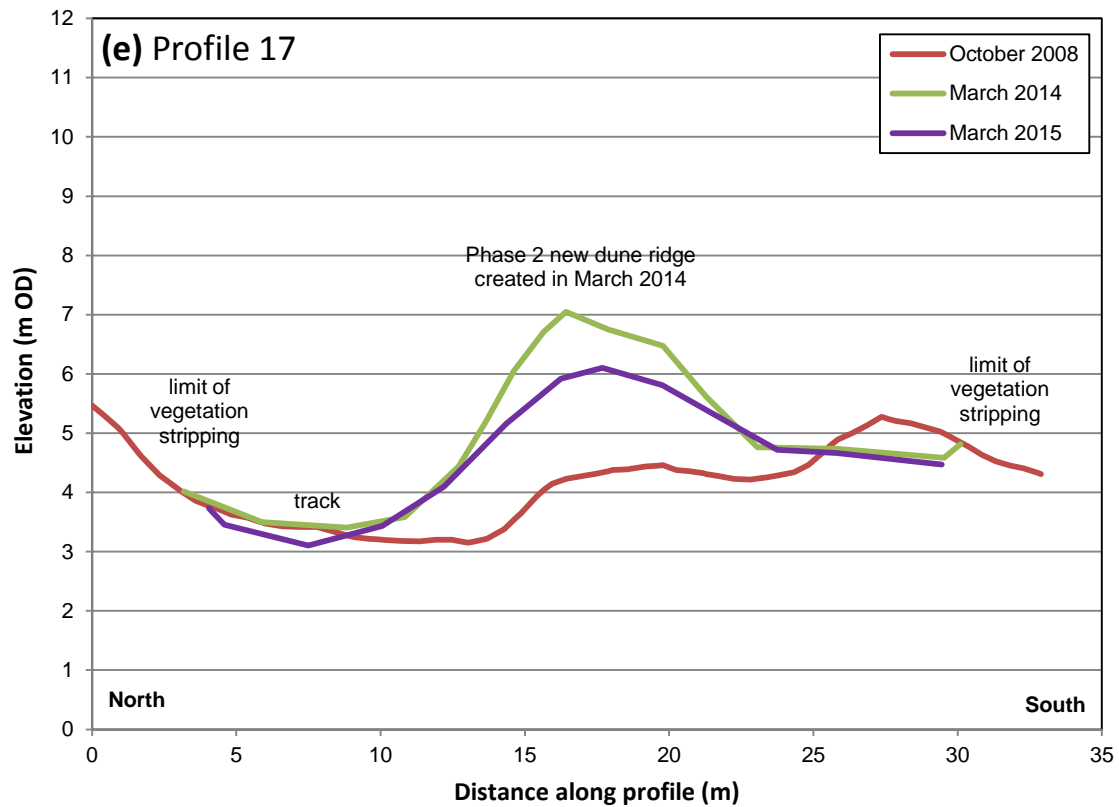
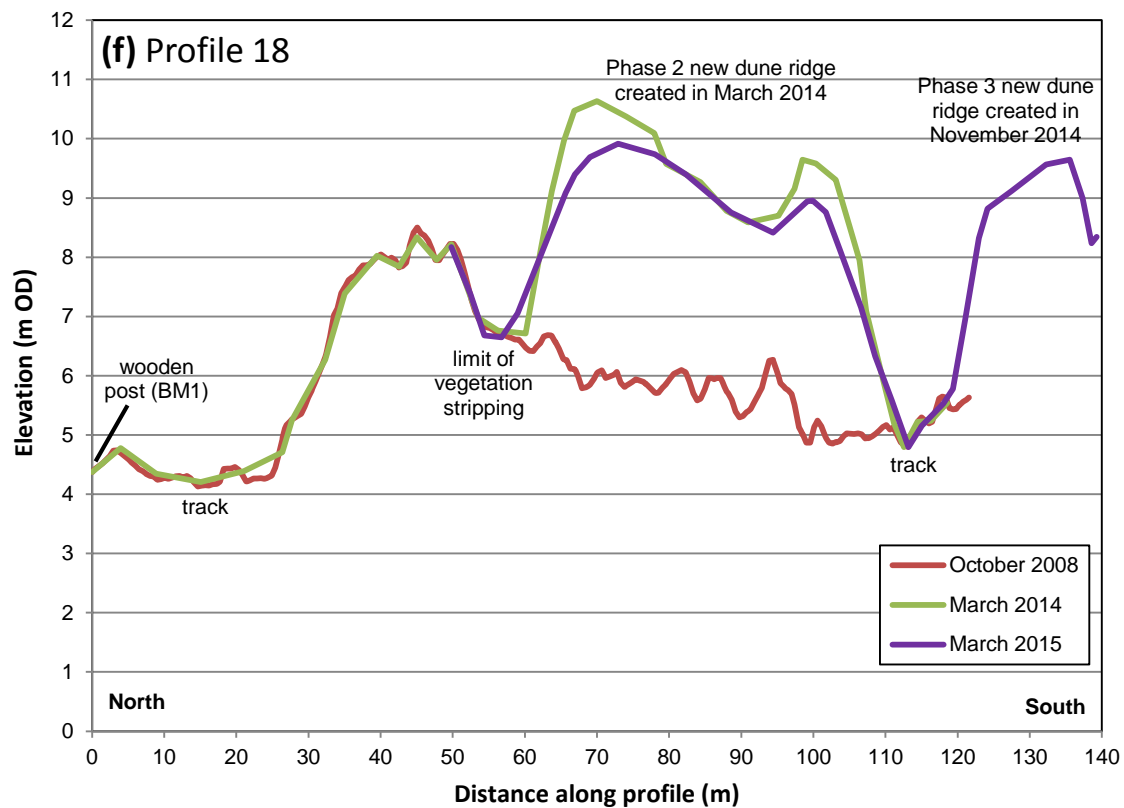
Figure 7 (continued). Comparison of surface levels at profiles 17 and 18 on the Phase 2 site indicated by LiDAR survey on 16-29th October 2008 (pre-trials) and ground surveys on 11 March 2014 and 11-12 March 2015.

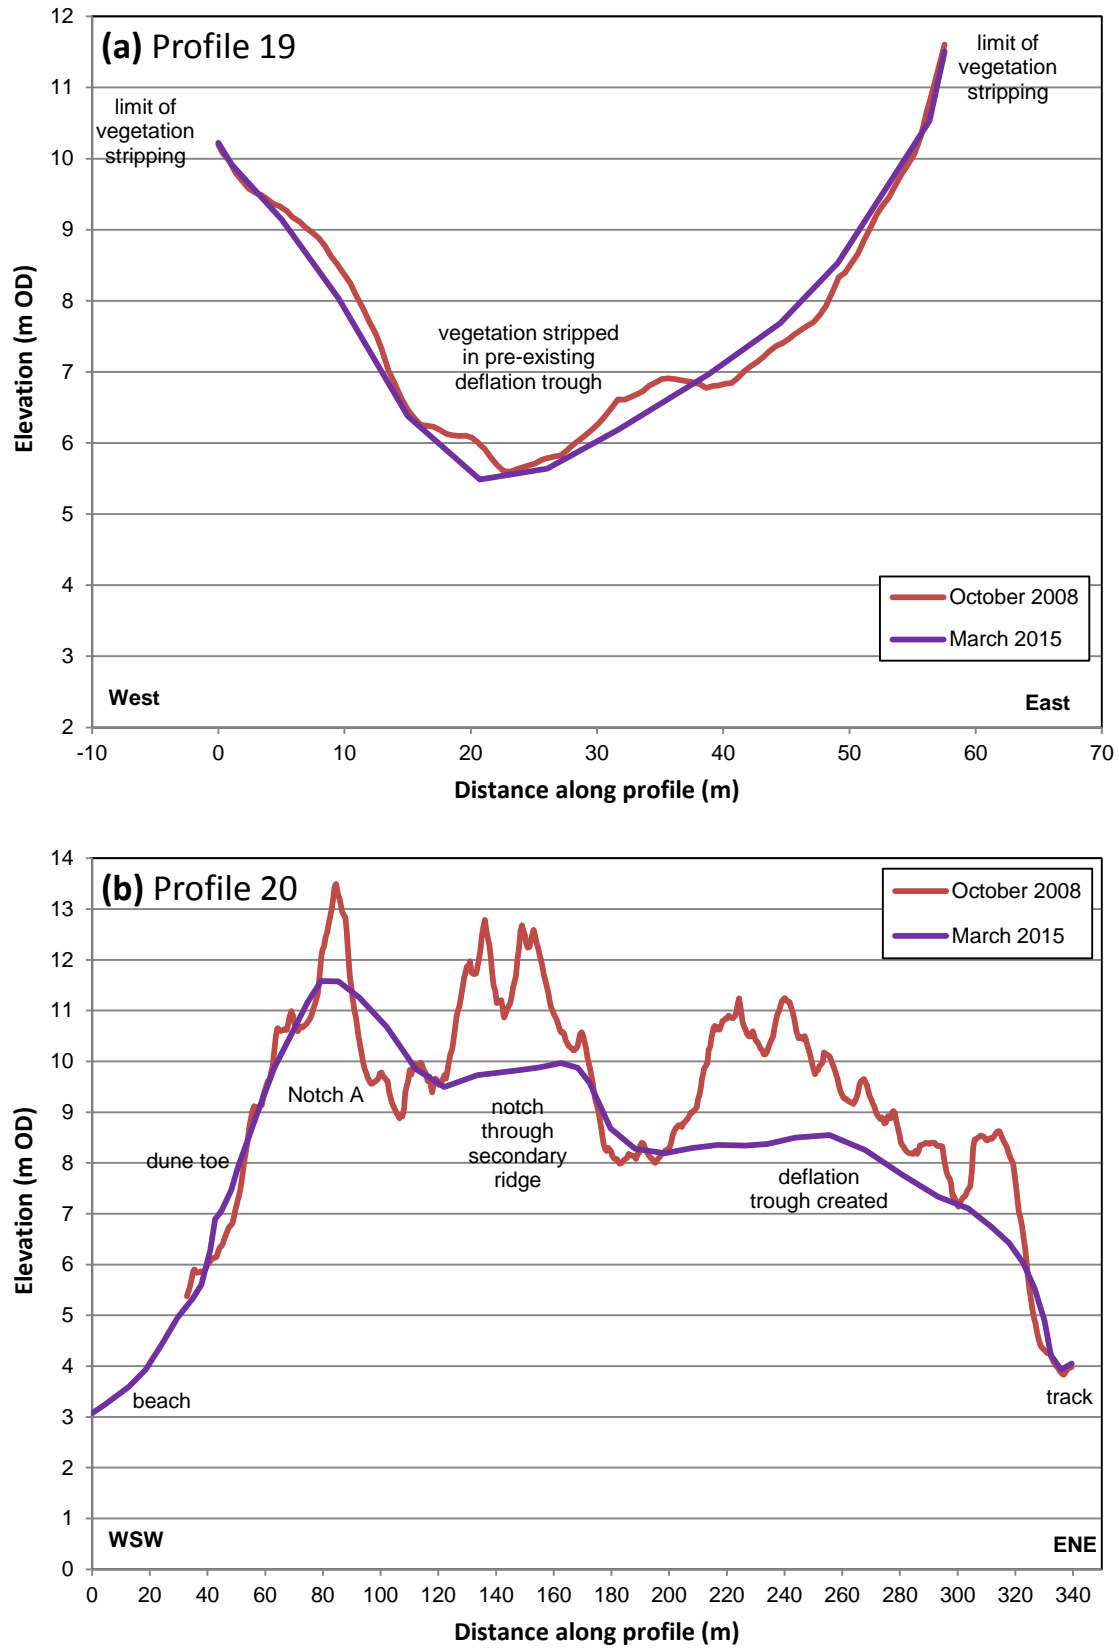
Figure 8. Comparison of surface levels at profiles 19 and 20 on the Phase 3 site indicated by LiDAR survey on 16-29th October 2008 (pre-trials) and ground survey on 11-12 March 2015.

At the northern end of the site, vegetation has been stripped across the shore-parallel valley (Figure 8a: Profile 19), with sand being placed in a 'dam' across the valley to the north of the site. Profiles along the axes of notches A, B and C (Profiles 20-22) show that the notches were cut and re-profiled to a depth of 2-3 m through the frontal dune ridges, with the base of the deflation corridors remaining at or above 8.0 m OD (the elevation of the dune toe) for their length. At the time of survey a steep slip face was evident at the landward end of the notches where the sand is migrating eastwards into an area of trees and a pre-existing pond.

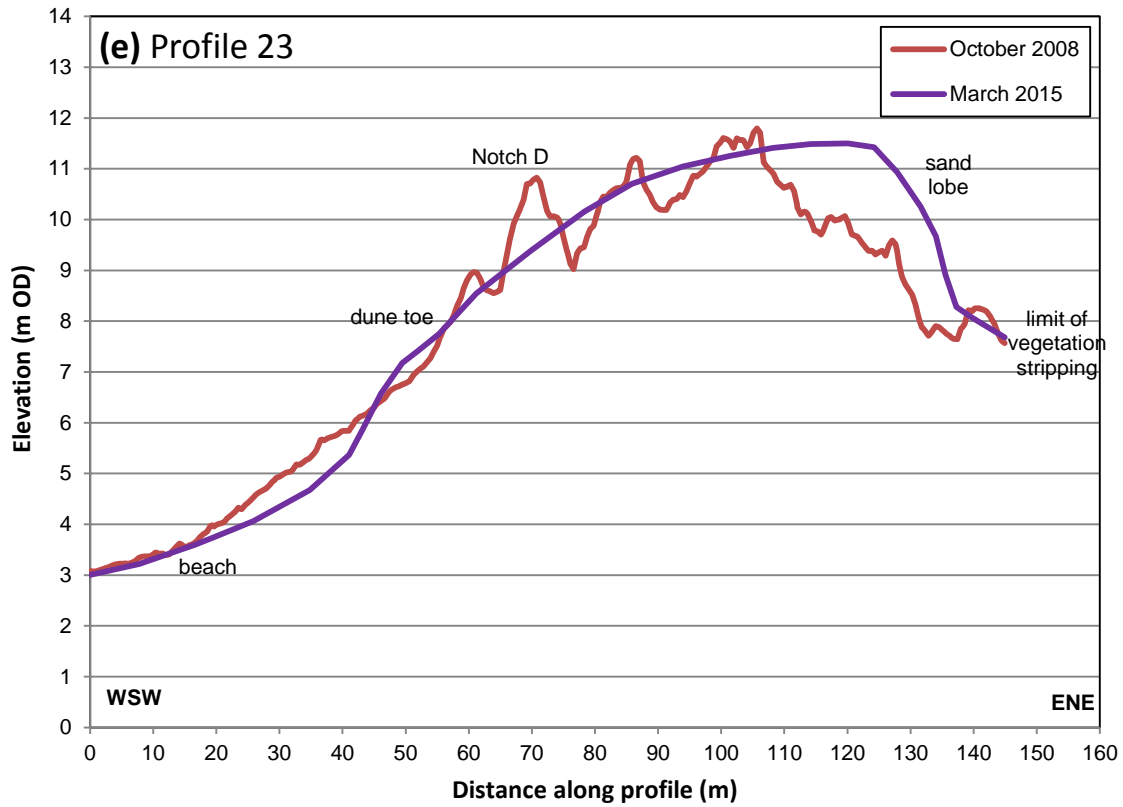
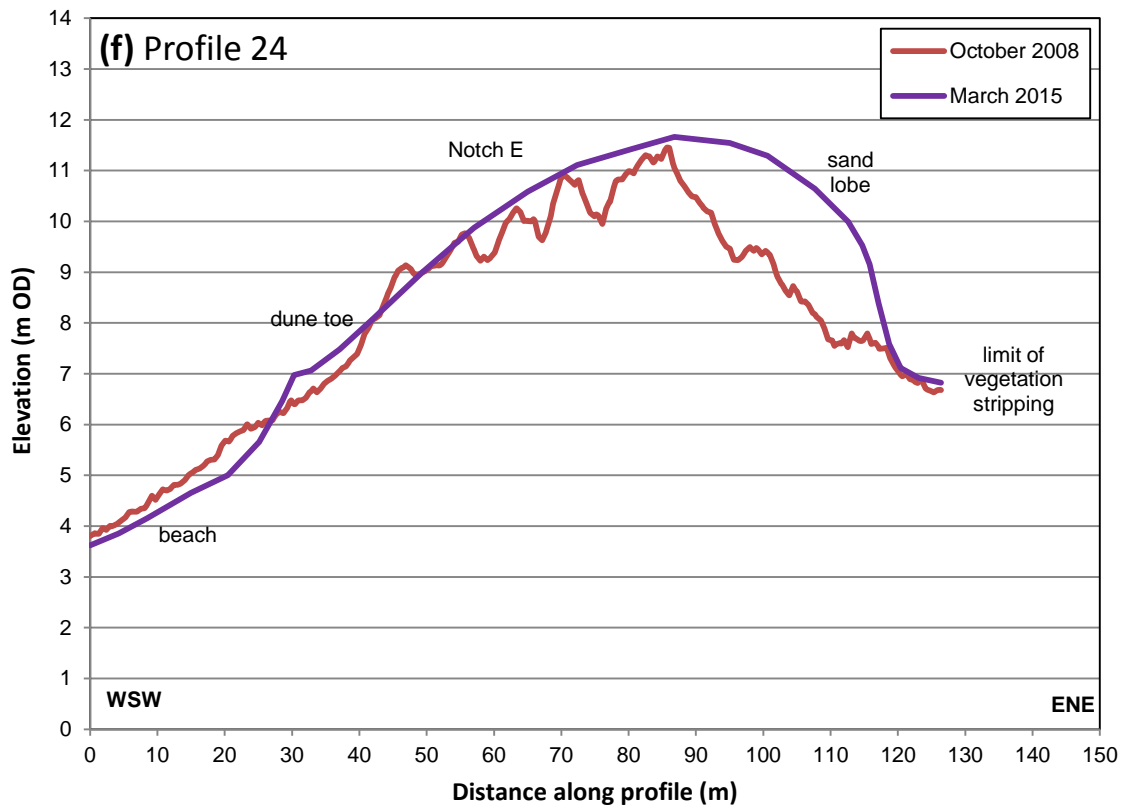
Figure 8 (continued). Comparison of surface levels at profiles 23 and 24 on the Phase 3 site indicated by LiDAR survey on 16-29th October 2008 (pre-trials) and ground survey on 11-12 March 2015.

Notches D, E and F (Profiles 23-25) were cut to a shallower depth of approximately 1 m, not appreciably more than was required to strip the vegetation. At the eastern end of notches D and E, 10-15 m wide sand lobes have formed by sand migrating along the notches. The parabolic dune behind notch F has been stripped of vegetation to expose bare sand. Some sand was used to lengthen and raise the northern arm by approximately 2 m (see northern end of Profile 39). At the head of the parabolic dune sand is accumulating (Profile 41) and migrating eastwards to form a sand lobe (Profile 25).

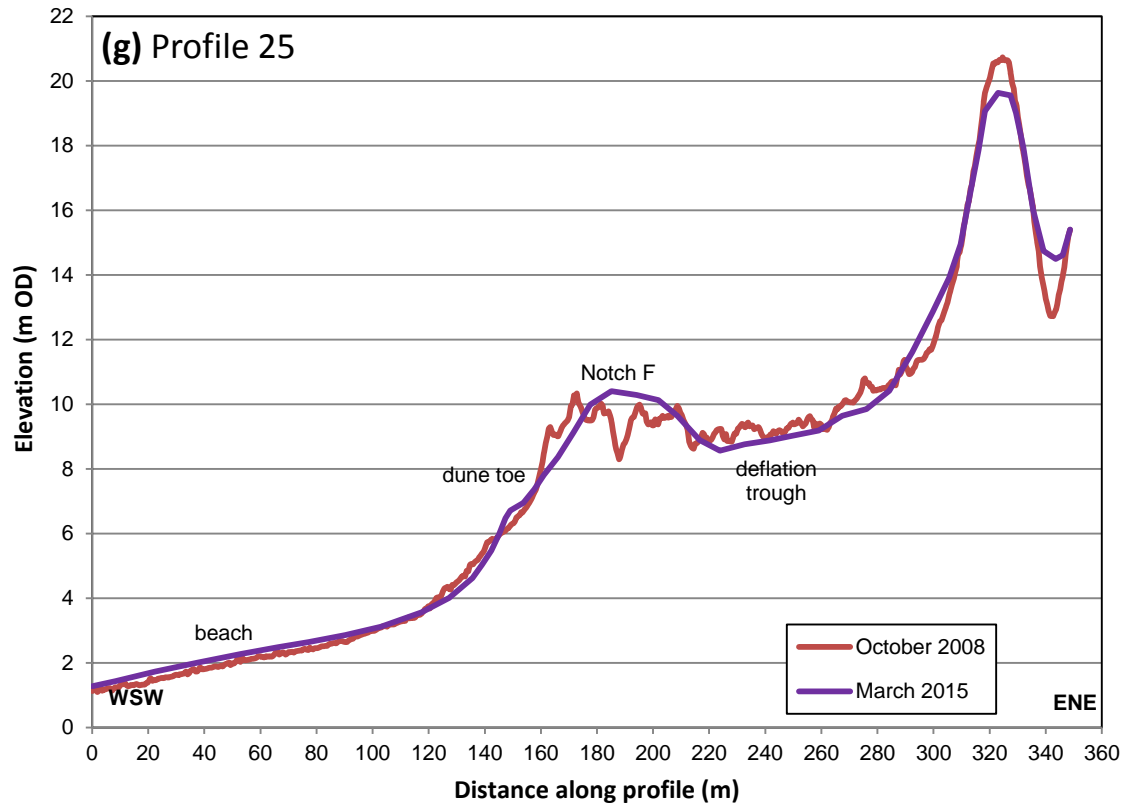
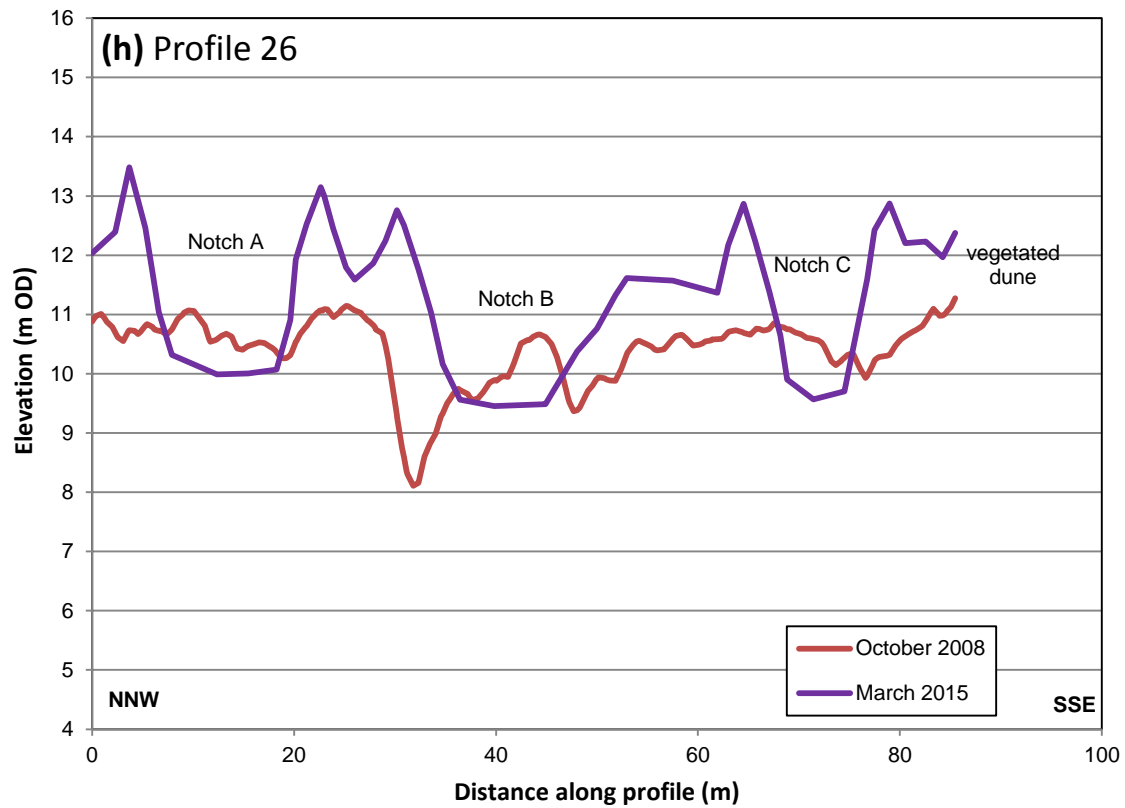
Figure 8 (continued). Comparison of surface levels at profiles 25 and 26 on the Phase 3 site indicated by LiDAR survey on 16-29th October 2008 (pre-trials) and ground survey on 11-12 March 2015.

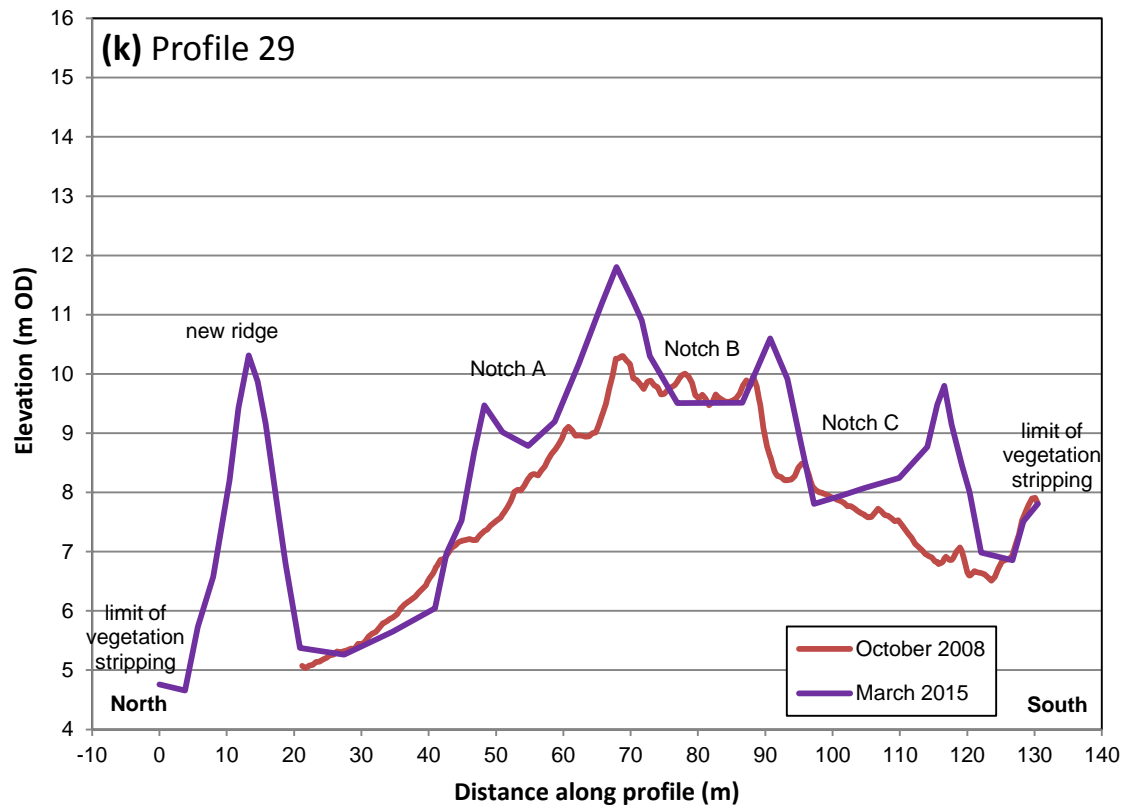
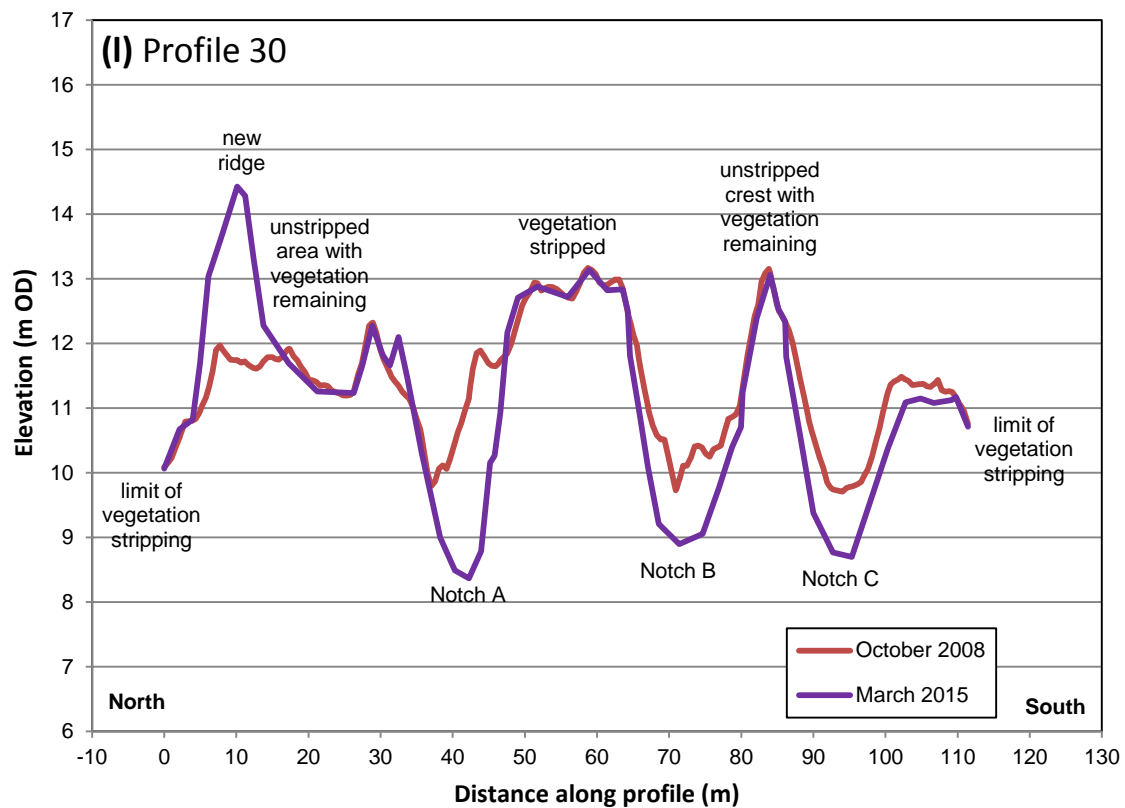
Figure 8 (continued). Comparison of surface levels at profiles 29 and 30 on the Phase 3 site indicated by LiDAR survey on 16-29th October 2008 (pre-trials) and ground survey on 11-12 March 2015.

In the north-eastern part of the Phase 3 area, crossed by Profiles 29-32, a new ridge has been created, approximately 5 m high, with a crest level reaching approximately 11-14 m OD, along the northern edge of the site. The southern boundary of this area, 100 m to the south, is formed by a pre-existing dune ridge which has not been stripped of vegetation, reaching a similar elevation of 12-14 m OD. A generally flat, vegetation-stripped plateau has been created in between, with shallow (c. 1 m deep) troughs excavated to continue the alignment of notches A, B and C in a WSW-ENE direction.

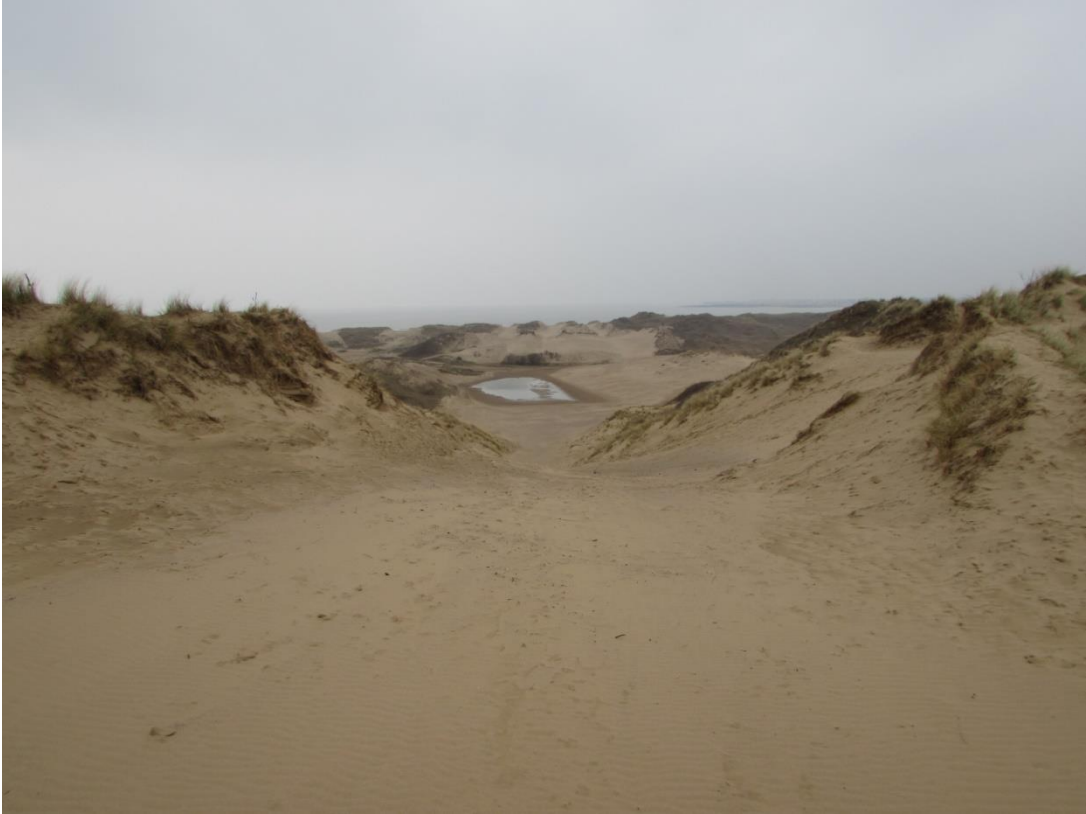
Photograph 1. Central axis of the Phase 1 area, looking WSW

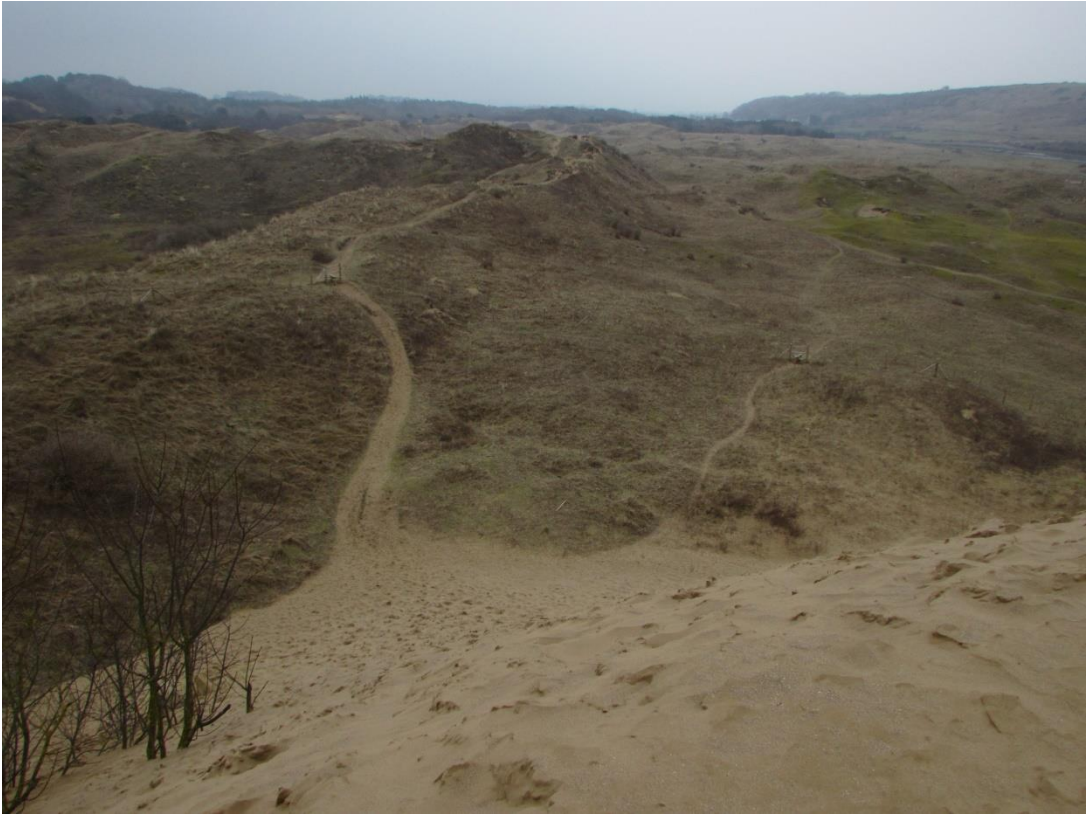
Photograph 2. The dune ‘nose’ at the eastern end of the Phase 1 area, with the Ogmore valley in the distance, looking east

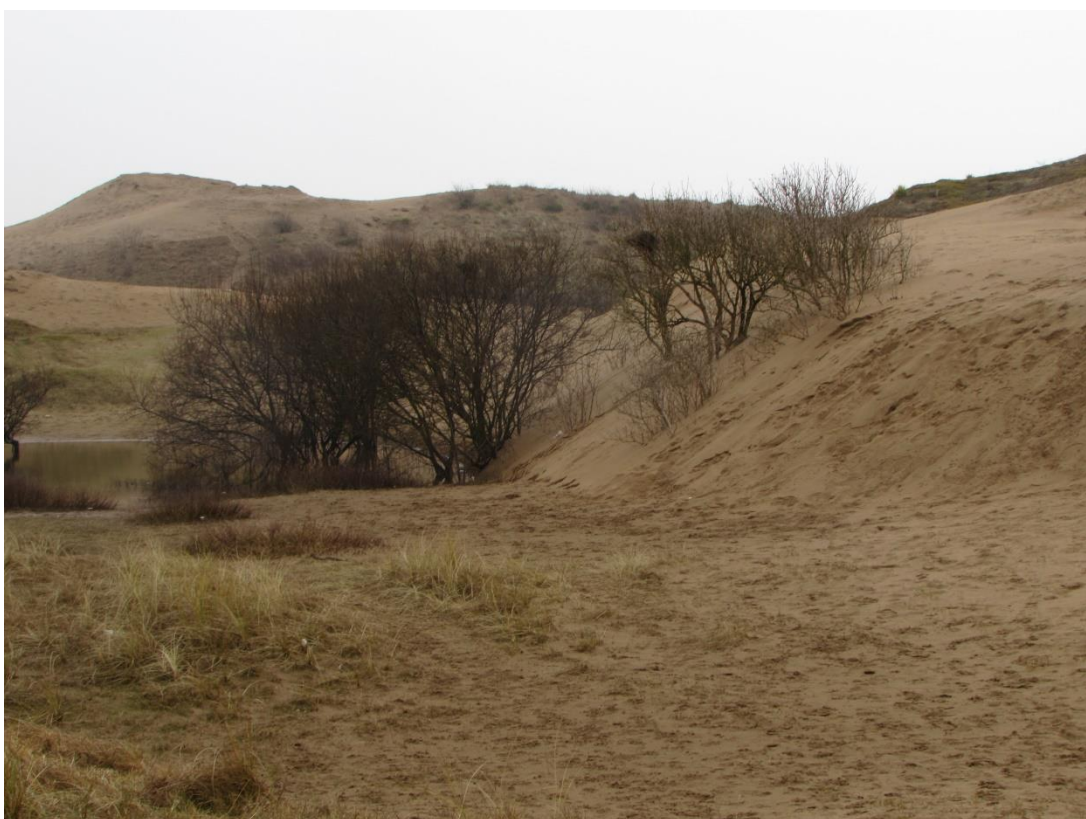
Photograph 10. The slip face at the eastern end of the Phase 3 area, sand beginning to bury the trees and enter the pond, looking south
