Arboricultural Impact Assessment

Llyn Tegid (Bala Lake) Reservoir Safety Project

Our Ref: 19/AIA/SNP/10

November 2019

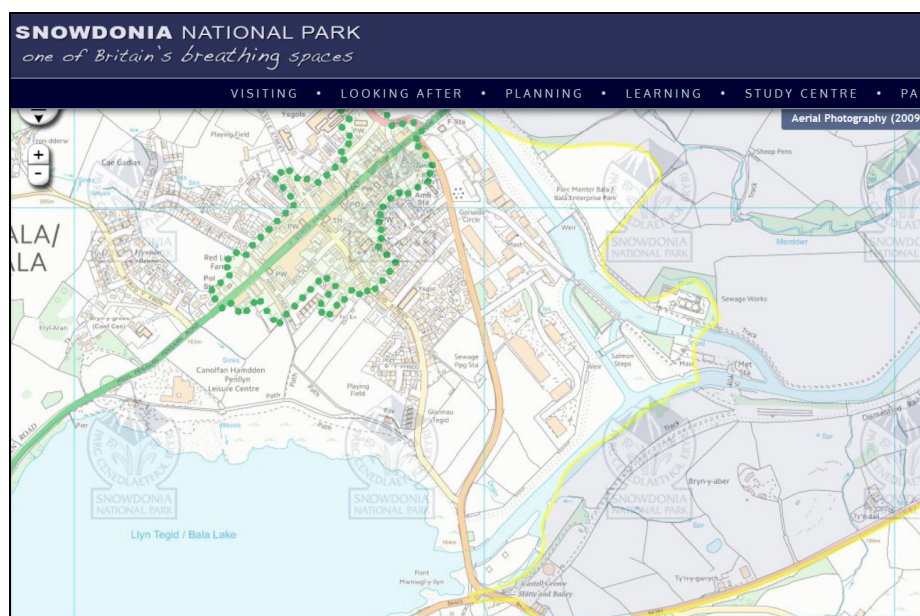
Plate 1 – Extract from SNP interactive map indicating that the site falls outside Bala Conservation Area which is marked in green

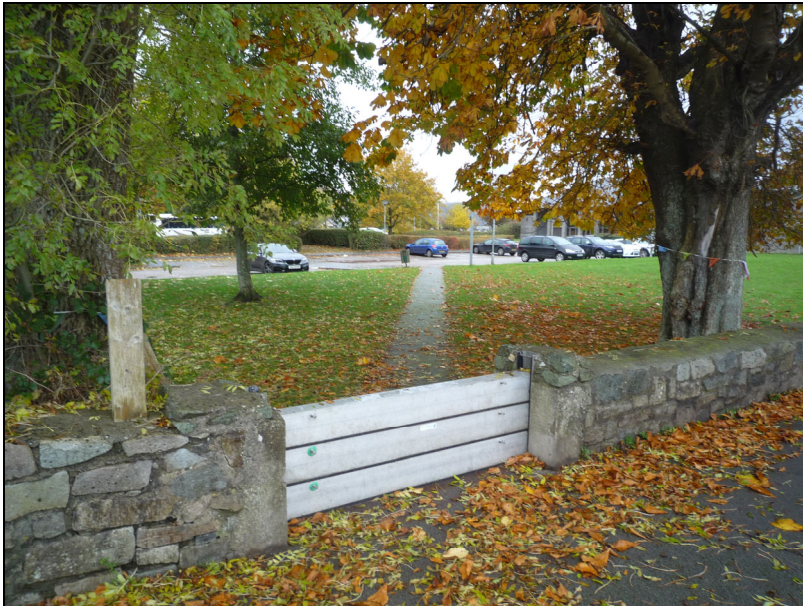
**P1 – Gap in existing wave wall to be filled and tarmac footpath lifted within RPA
Of tree numbers 96 & 97**

- 8.5 The public footpath that runs between tree numbers 96 and 97 is to be moved to a new location to the east and the gap in the existing wave wall in this location is to be filled to match the wall either side. This will involve lifting the existing tarmac surface dressing within the RPA of the trees and excavating within the gap in the wall to install the necessary block foundation for the inlay wall section as detailed on Black & Veatch Drawing Ref: 122918-BVL-Z0-00-DR-C-100007 (Rev P03) and in the engineer's cross section drawing below. All excavation works within the RPA of trees will be undertaken by hand and under the direct on-site supervision of the project Arboricultural Consultant – see Arboricultural Method Statement.

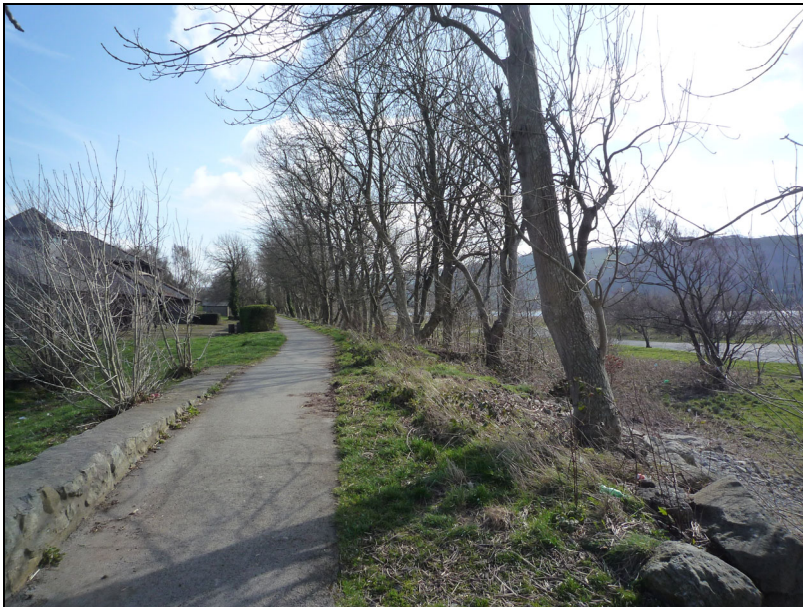
**P2 – Group 1 viewed from footpath west of Leisure Centre. Note all trees have
been topped out at 9m resulting in weak secondary crown above**

- 8.3 The principal impact will be the removal of tree groups 1 and 4-8 that form linear closed canopy groups on the embankment to the south of the footpath around Llyn Tegid reservoir. These trees have naturally colonised this embankment due to lack of any past formal site management and they should be considered for removal as appropriate management of the existing embankment. A significant number of these trees display evidence of Ash Dieback (*Hymenoscyphus fraxineus*) that will lead to their inevitable early demise. All have seen significant crown reductions/topping leaving an unnatural appearance and poor structural forms with potential to fail due to the adventitious secondary crowns having a weak attachment to the parent stem. These trees have exploited the small gaps between boulders that make up the embankment and most have now outgrown their confined rooting environment and exhibit multiple physiological and morphological disorders as a result. As such, remedial tree management works are required irrespective of the proposed works.

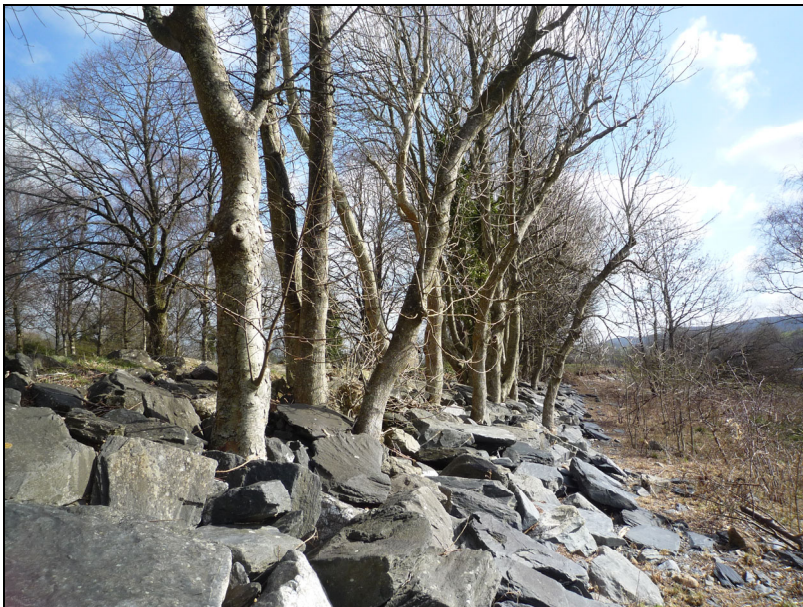
**P3 – Base of trees in G1 growing out between gaps in existing embankment.
Many boulders have become embedded in stems & there is insufficient space for
further establishment without potential fractures**

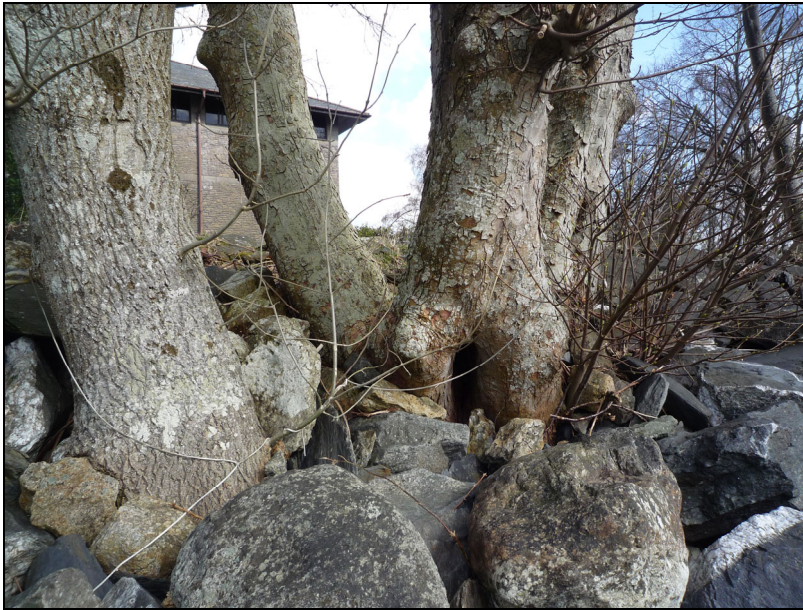
P4 – Embedded rocks/boulders and physiological disorders to base of stems in G2. Trees have limited long-term potential irrespective of proposed works

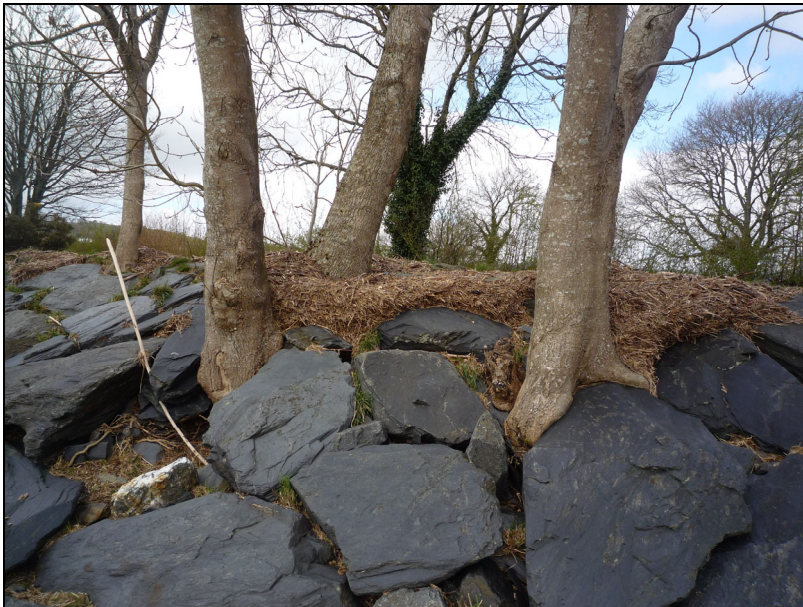
P5 – Embedded rocks/boulders at base of stems on group 4. These cause potential fracture points when trees are loaded or during inclement weather

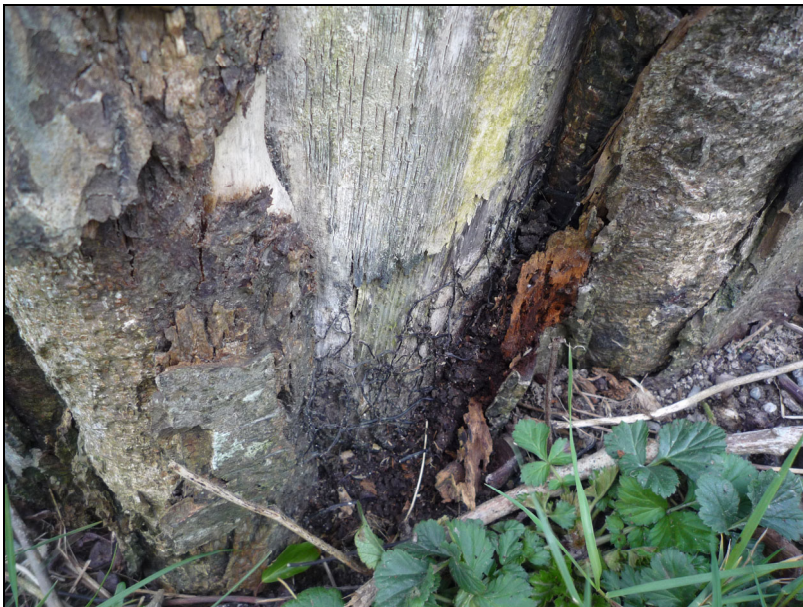
P6 – Rhizomorphs of Honey Fungus at base of T9

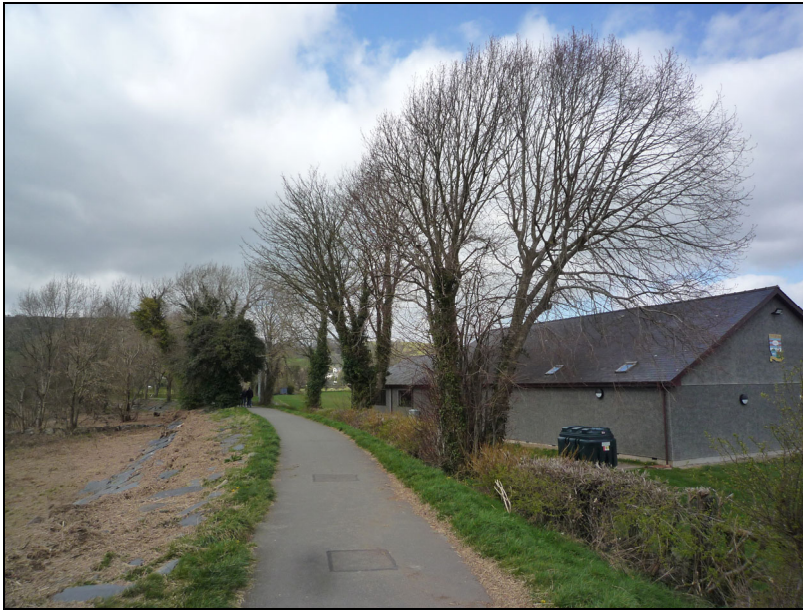
P7 – T25-T29 to be removed

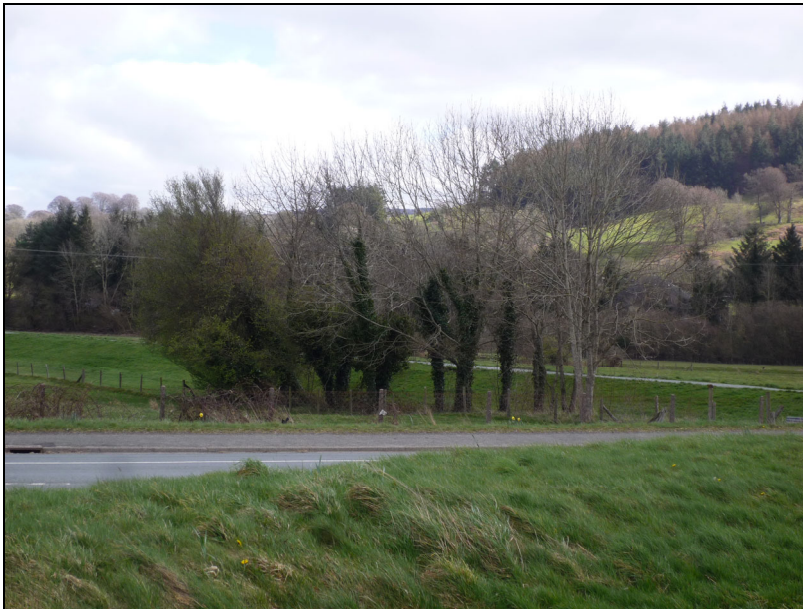
P8 – G12 & G13, small unmanaged ivy clad trees to be removed

G12	Ash	SM / EM	≤9					≤150	G	<ul style="list-style-type: none"> Linear group of trees at 0.5m centres – self set and easily replaced by new planting post works Evidence of Ash Dieback in crowns E.R.C 10 	<ul style="list-style-type: none"> Remove for proposed works 	C2	1.8m 10m ²
G13	Cherry Plum	M	≤12	2	2	5	2	≤200	G	<ul style="list-style-type: none"> No visual defects Easily replaced post completion of works E.R.C 10 	<ul style="list-style-type: none"> Remove for proposed works 	C2	2.4m 18m ²

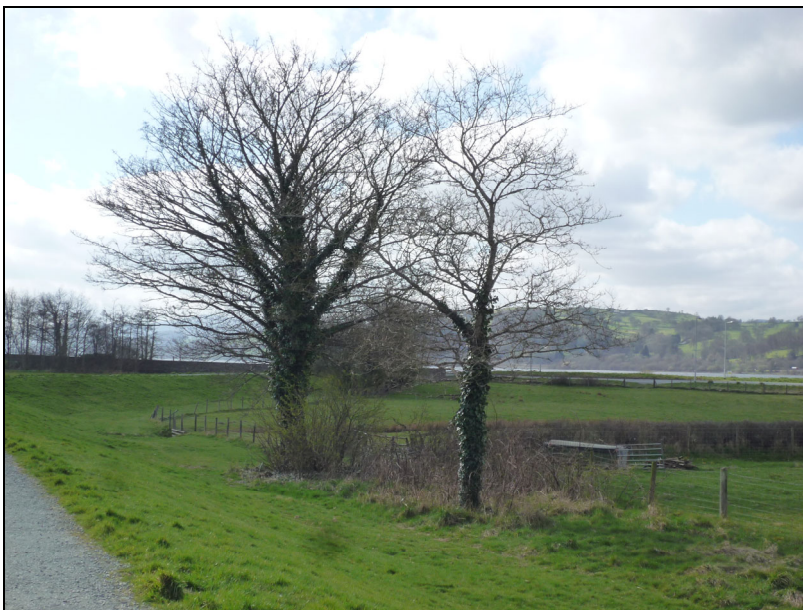
P9 – T35-T37, semi-mature/early mature small diameter trees

8.6 Enkamat erosion control matting and concrete Armorloc blocks are to be laid within the RPA of tree numbers 1-5, 17, 35, 36 & 38 – refer to Black & Veatch Drawing Ref: 1229-18-BVL-Z0-00-DR-Z-00004 (Rev P01). Whilst this is an incursion within the RPA of these trees, any adverse impact on their future health and vigour has been discussed at the design stage with Tree Solutions with the following being considered as the least disruptive.

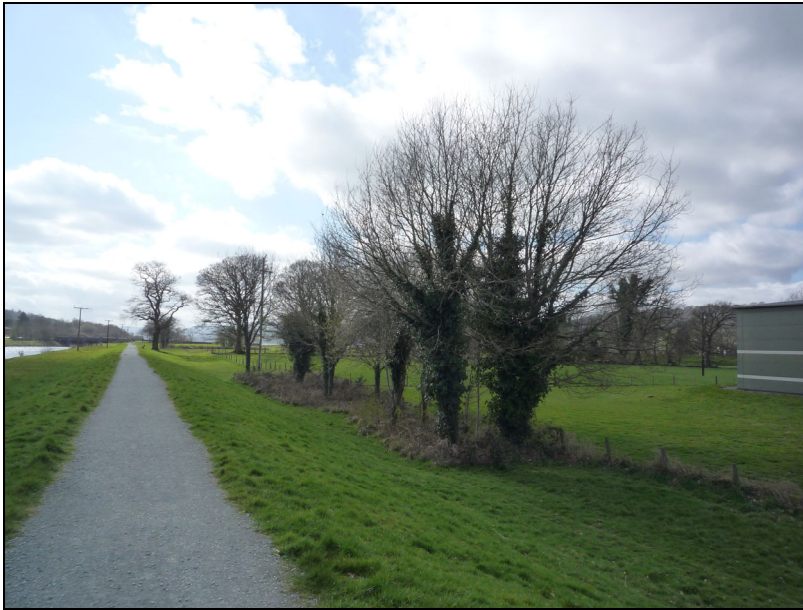
P10 – T41-T49 forming small linear copse of Ivy clad trees

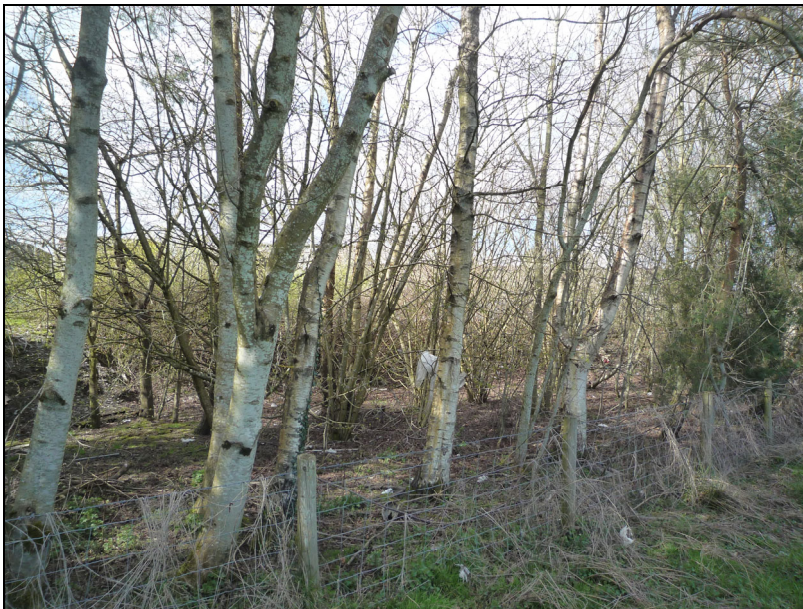
P11 – Group 14, linear group screening industrial area beyond

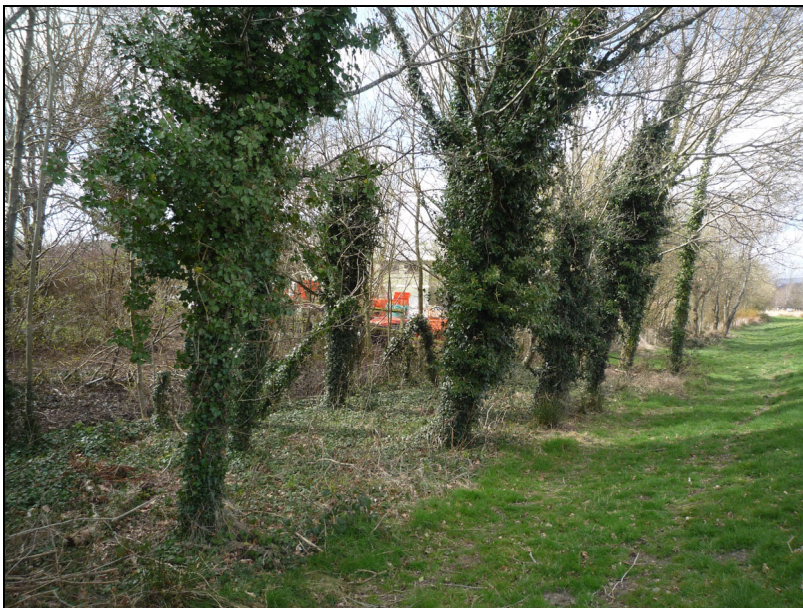
P12 – Group 17, Ivy clad unmanaged trees

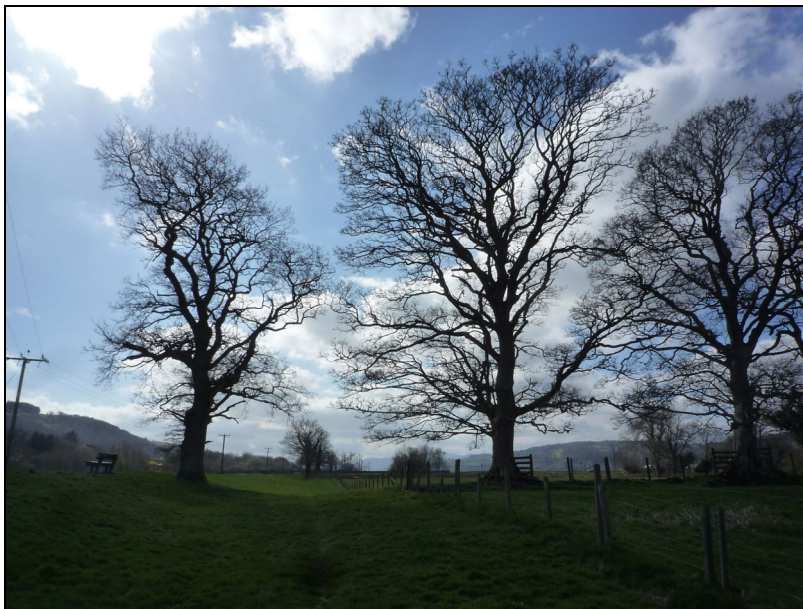
P13 – Tree numbers 38 & 39 mature landscape features
